Work Category No.	215 – STRUCTURES COMPONENT REPLACEMENT			
Sub-category Description	215F - GUARDRAIL AND BARRIER COMPONENT REPLACEMENTS (NOT ON BRIDGES)	Quality Assurance Statements		
Author:	s 9(2)(a)	Capital Journeys Marine Parade Petone Wellington  PO Box 38 208 Wellington Mail Centre 5045	Prepared by	Date
Owner (NZTA)	s 9(2)(a)		s 9(2)(a)	
Audience:	NZTA; Capital Journeys		Reviewed by	Date
Stakeholders:	NTA; Capital Journeys		s 9(2)(a)	
Status:	DRAFT	Version	Dates	
Distribution:	s 9(2)(a)		Purpose	
Security:	Open	0.1	13/9/16	Document creation
Document purpose:	Support Annual Plan Submission	0.2	9/12/16	General revision
Document linkage:	2017/18 Annual Plan	0.3	24/01/17	General revision
Document expiry:	February 2017			
Key Words:	AP17/18

Summary of Proposed Activities
<p><b>Purpose Statement</b></p> <p>Road safety barriers are designed to contribute to road safety outcomes by containing and redirecting errant vehicles and thereby preventing them from leaving the road or crossing into the path of oncoming traffic. They also contribute to a forgiving roadside environment reducing the probability of a fatality or serious injury to the occupants when a vehicle leaves the highway.

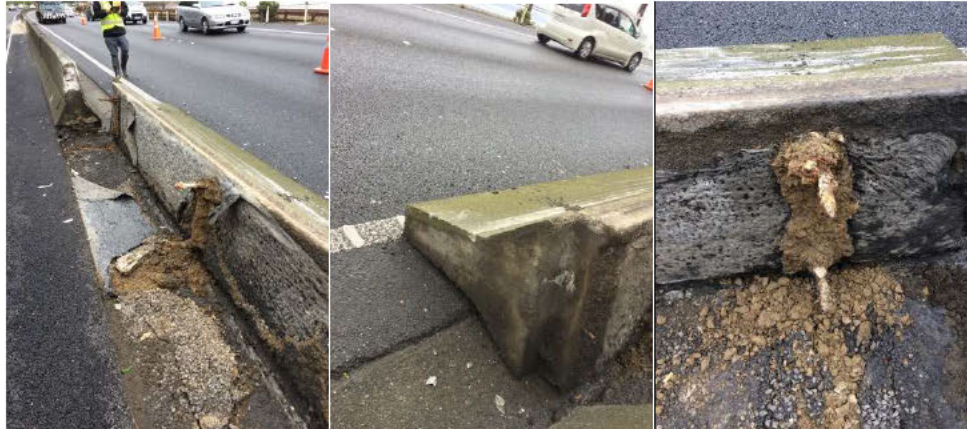
The second example occurred on the median New Jersey Barrier of State Highway 2 Hutt Road running from RP12,929m to 14,514m on the 11th of November 2016. The barrier was struck by a light passenger vehicle and toppled over immediately behind the right hand edge line of the southbound traffic lanes. This occurred at the start of the morning peak traffic period and was a significant hazard to vehicles travelling in the right hand lane in both directions. Fortunately peak travel speeds were relatively slow but, the traffic volume was high. The barrier was subsequently righted and placed back into position

In both examples the New Jersey Barrier units were not connected to the adjacent units and ground pins were in poor condition, rusted and only embedded in the in-situ ground. This resulted in there being no ribbon strength along the length of the new jersey barrier or ability of the individual units to resist the impact loads.

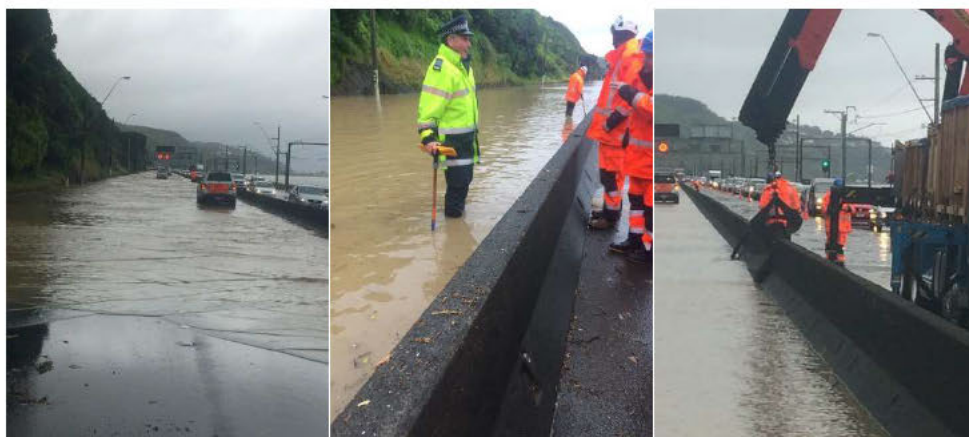
Furthermore, during the rainfall event on the 15<sup>th</sup> of November the new jersey barrier in the median of State Highway 2 RS962/12.85-1 acted as a dam preventing water from draining from the road surface, due to insufficient drainage at the base of the barrier units.

Remedial solutions to improve connections between the barrier units will prevent individual units from being lifted in similar events to allow flood water to be drained, as shown in the photo below. Where as the full renewal option allows for an opportunity to improve the drainage capacity and reduce the likelihood of further flooding.

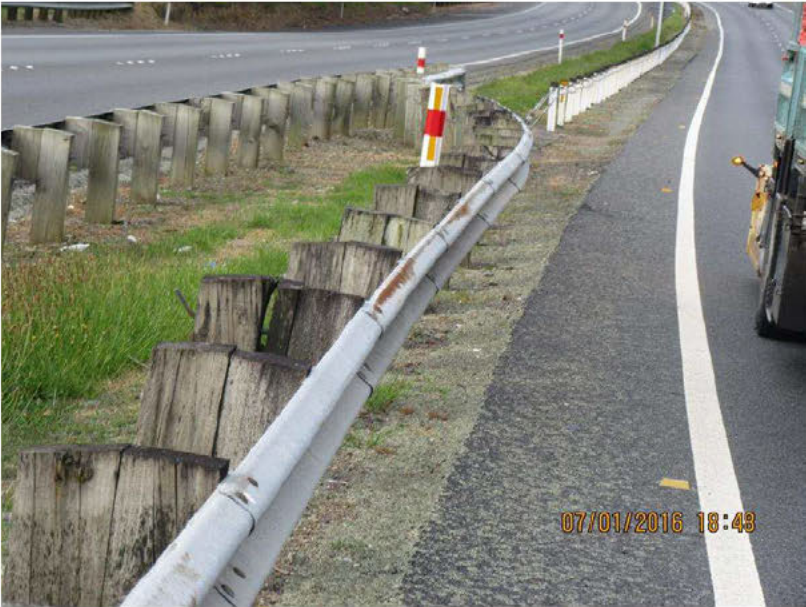
Sample Photographs		
	Photograph	RS/RP
Example 4

<p>Lengths of w-section guard rail showing surface rust and older aged posts</p>	SH01N-RS1050-I 9164m to 9628m
Example 5

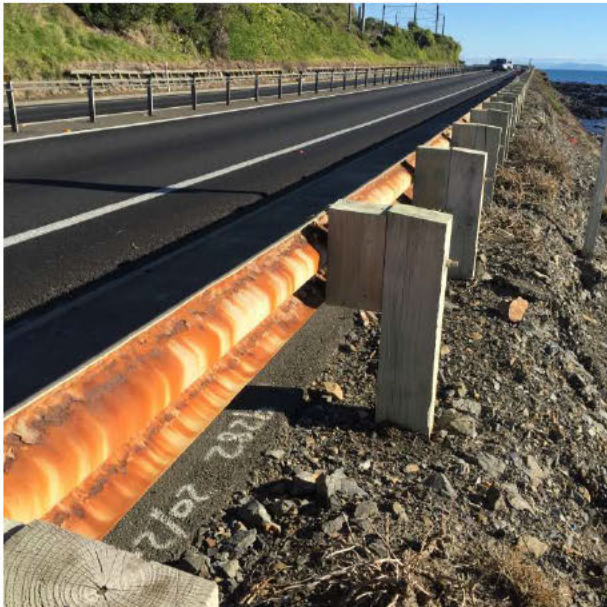
<p>Extensive rust along back of w-section guardrail</p>	SH01N-RS1035/0.154-D 1801m to 2309m
